**REPAIR, EVALUATION, MAINTENANCE, AND  
REHABILITATION RESEARCH PROGRAM**

TECHNICAL REPORT REMR-CS-8

**IN SITU REPAIR OF DETERIORATED  
CONCRETE IN HYDRAULIC STRUCTURES:  
FEASIBILITY STUDIES**

May 1987  
Final Report

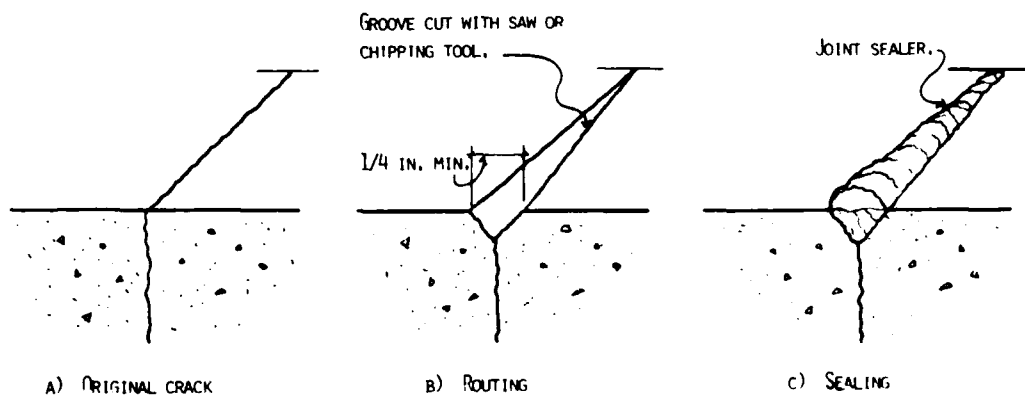
Figure 4. Repair of crack by routing and sealing (ACI Committee 224, 1984).

The technique simply entails enlarging the crack along its exposed face and filling and sealing it with a suitable joint sealant (Figure 4). Choice of the sealant depends on how tight or permanent the seal must be. Epoxy compounds are most commonly used, although hot-poured joint sealants have been used when watertightness is not required and appearance of the repair is unimportant. Urethanes, which remain flexible through large temperature variations, have been used successfully in cracks up to 0.75 in. in width.

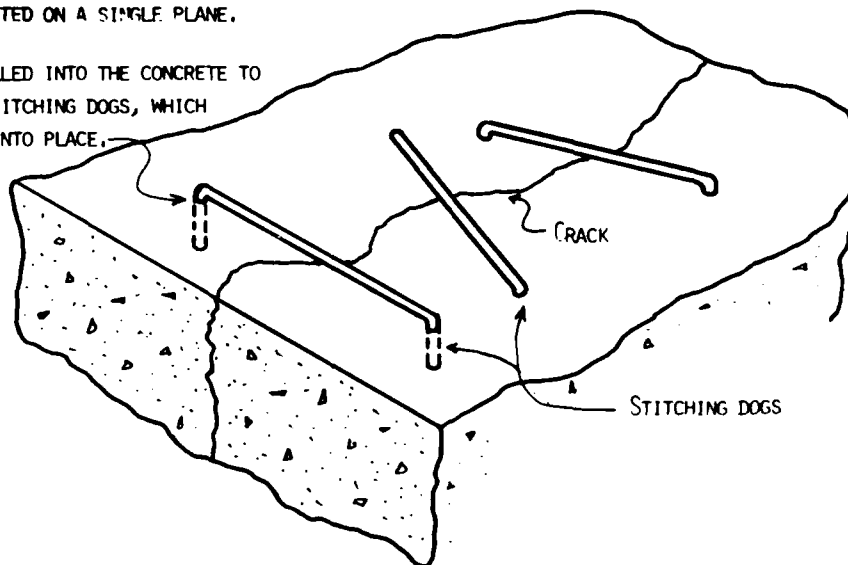
Figure 5. Repair of crack by stitching (ACI Committee 224, 1984).

3. Stitching. This technique involves drilling holes on both sides of the crack and grouting in U-shaped reinforcing bars (stitching dogs) that span the crack (Figure 5). A non-shrink grout or an epoxy resin is normally used to anchor the legs of the bars. Stitching is generally used when it is necessary to reestablish tensile strength across major cracks. Stitching does tend to stiffen the area being repaired, which may accentuate the overall stiffness of the structure and cause cracks to develop elsewhere. It is, therefore, generally necessary to strengthen the adjacent sections using external reinforcement.

NOTE VARIABLE LENGTH, LOCATION AND ORIENTATION OF DOGS SO THAT TENSION ACROSS CRACK IS DISTRIBUTED IN THE CONCRETE RATHER THAN CONCENTRATED ON A SINGLE PLANE.

HOLES ARE DRILLED INTO THE CONCRETE TO RECEIVE THE STITCHING DOGS, WHICH ARE CEMENTED INTO PLACE.

Stitching will not close a crack but can be used to prevent it from propagating further. If water is a problem, the crack should be made water tight before it is stitched to protect the bars from corrosion.

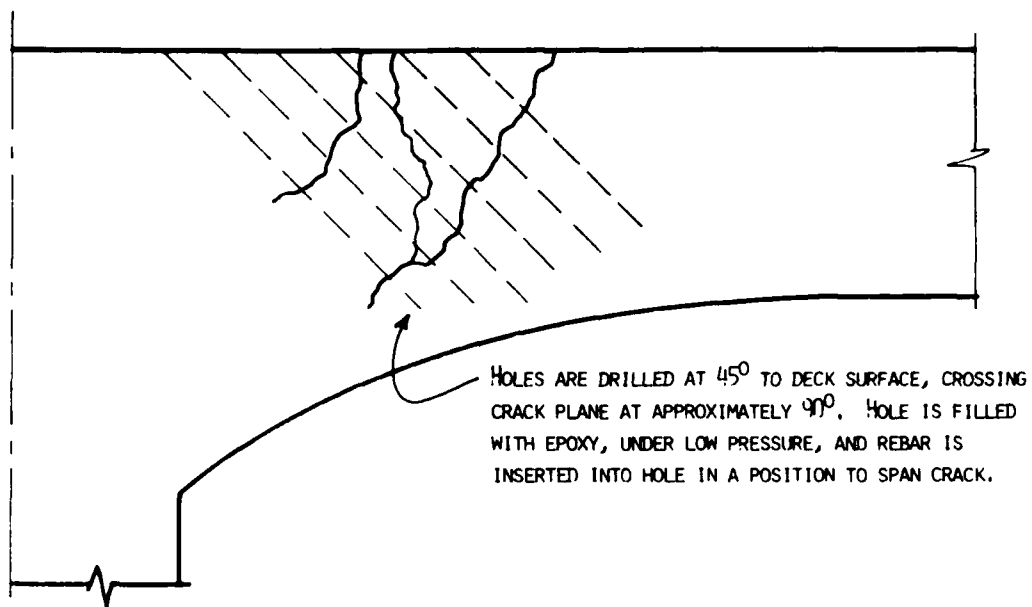
Figure 6. Repair of crack by post reinforcement.

Post-reinforcement is a technique developed by the Kansas Department of Transportation to repair cracked structural bridge concrete. The method consists of sealing the surface of the crack, drilling holes at  $45^\circ$  to the deck surface, and crossing the crack plane at approximately  $90^\circ$ , filling the hole and crack plane with epoxy pumped under low pressure, and placing a reinforcing bar into the drilled hole in a position to span the crack (Figure 6). The epoxy bonds the bar to the walls of the hole; it fills the crack plane, thereby rebonding the cracked concrete surfaces in one monolithic form and reinforcing the section.

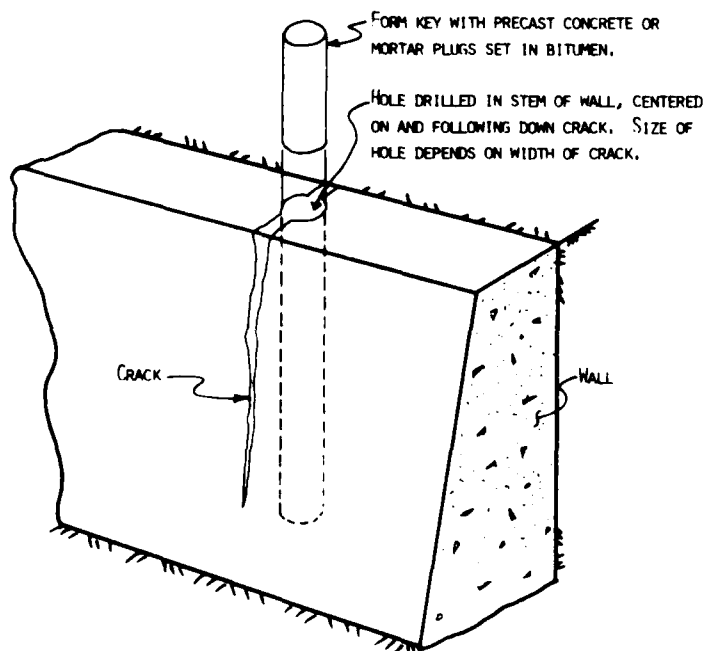
Figure 7. Repair of crack by drilling and plugging (ACI Committee 224, 1984).

5. Drilling and Grouting. This technique is useful for repairing vertical cracks which are reasonably straight and are accessible at one end of the crack such as in retaining walls. It consists of drilling a hole, usually 2 to 3 in. in diameter, down the length of the crack and grouting it in to form a key (Figure 7). The grout key prevents transverse movement of the concrete adjacent to the crack and will also reduce heavy leakage through the crack. If watertightness is essential and structural load transfer is not, the drilled hole is filled with a resilient material in place of the grout.

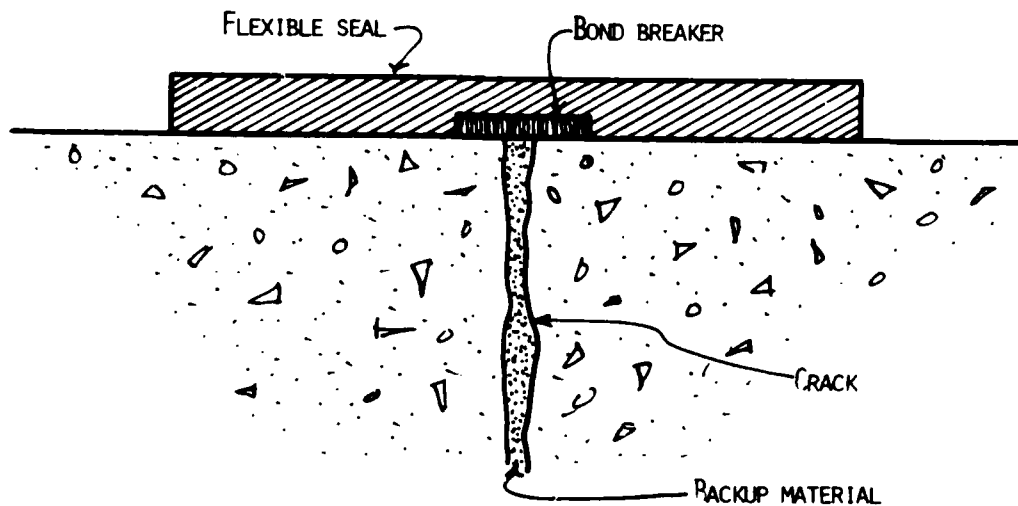
Figure 8. Repair of crack using a flexible seal (ACI Committee 224, 1984).

6. Flexible Sealing. Active cracks can be sealed by routing them out and filling them with a suitable flexible sealant. This technique is applicable where appearance is unimportant and in areas where the cracks are not subject to traffic or mechanical abuse. The repairs are made by routing out a slot or groove along the length of the crack of sufficient width and shape to accommodate the expected movement. The slot is then filled with a backing material, covered with a bond breaker, and finally sealed with the flexible joint sealant (Figure 8).

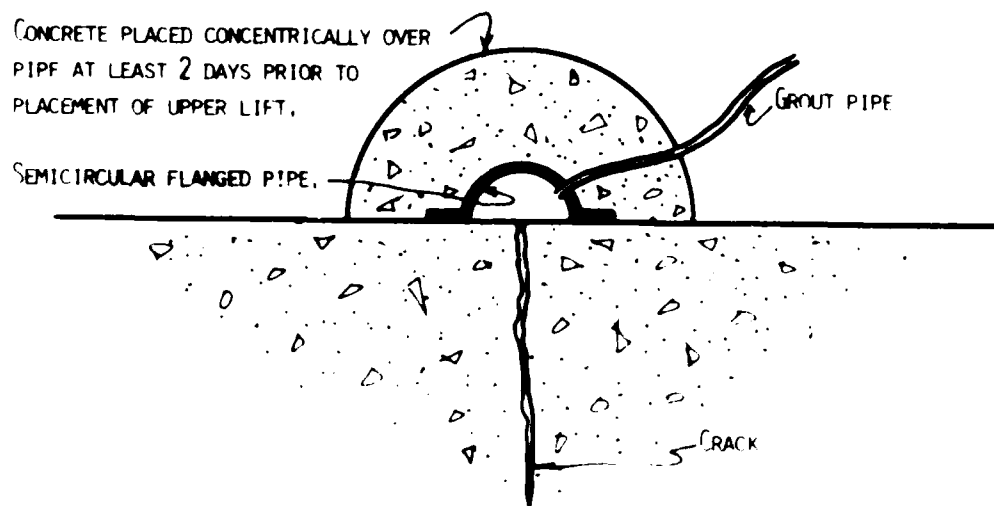
Figure 9. Repair of crack using the crack arrest method (ACI Committee 224, 1984).

9. Crack Arrest. This technique is commonly used to prevent reflective cracking into new concrete which is being placed over existing concrete. The technique, in general, arrests the cracking by blocking it and spreading the tensile stresses causing the cracking over a larger area. One technique consists of placing semicircular sections of steel pipe over the crack and then covering the pipe with concrete to anchor it in place. After this concrete cap has set, the new concrete is placed over the cap. The steel pipe is later filled with grout to complete the structural continuity of the member (Figure 9).

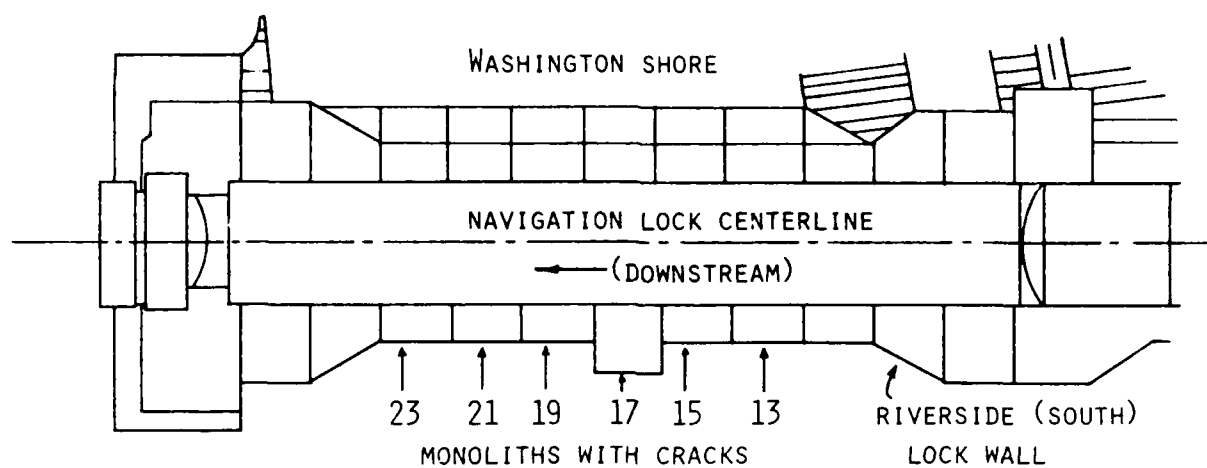
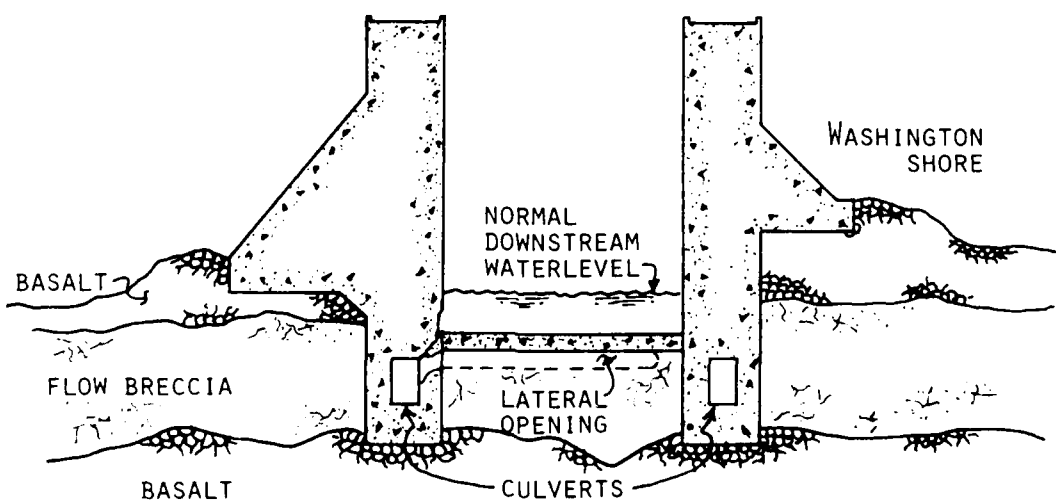
Figure 14. John Day Navigation Lock.

1. John Day Navigation Lock and Dam, Oregon (1981). The John Day Lock and Dam is located on the Columbia River between Oregon and Washington about 110 miles upstream from Portland, Oregon. The lock is 675 ft long, 86 ft wide, and provides a maximum lift of 113 ft (Figure 14). The lock began operation in 1968.

During an inspection in 1975, significant structural cracking and related spalling were discovered in two of the lock monoliths, monoliths 17 and 19. By 1979, cracking and spalling had been detected in four additional monoliths, monoliths 13, 15, 21, and 23. The structural distress in the monoliths consisted of cracks that originated at and propagated from the upper inside corner of the filling and emptying culvert and terminated at the surface of the wall in the lock chamber. Because of the continued progression of the cracking and spalling, a series of remedial repair procedures were devised and implemented to halt and correct the ongoing deterioration (Adhesive Engineering Bulletin, 1981b, Barlow, 1986, and Neuberger, 1982).

The objectives of the selected repair procedures were to restore the existing cracked structure to near its original uncracked condition, to eliminate the cause of the cracking, and to effect the repairs without
